REPORT NUMBER: WI-06-04

Aluminum Sign Corrosion Investigation

FINAL REPORT

WisDOT Highway Research Study # WI-04-02

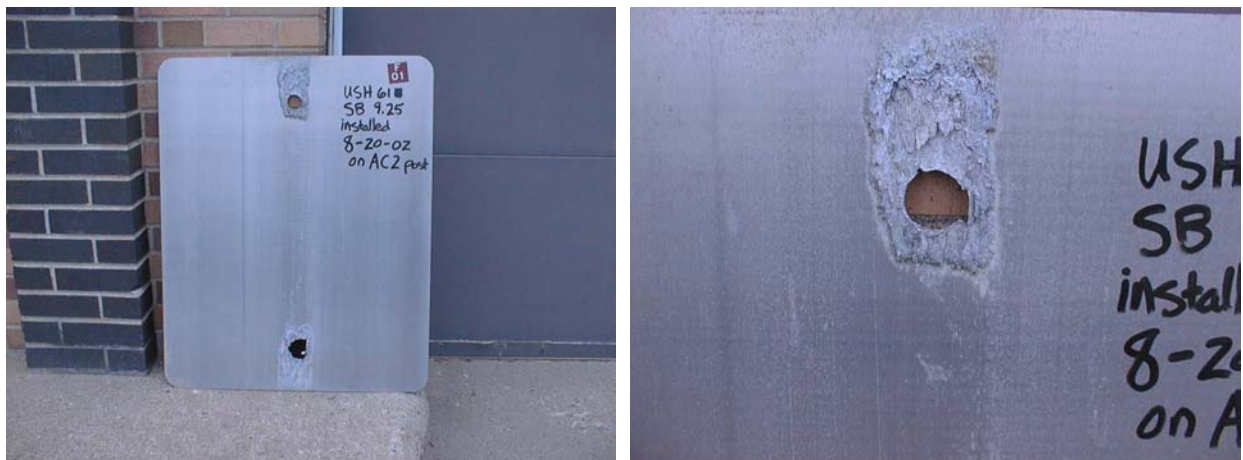
In this case the distress or corrosion appeared to originate around the galvanized lag bolts and spread out from there. The photographs below show the distress that is occurring.

These photographs show the backside of a sign that was installed 8-20-02 on an Alkaline Copper Quaternary (ACQ) treated wooden post. The sign fell off the post around mid-March 2004 after less than 2 years in service.

1. The major recommendation here is to apply a protective barrier between the aluminum signs and the ACQ treated wooden posts. It is recommended that a rubber spray or a rain/ice/weather shield type of barrier be used on the backside of the signs and that the barrier be applied to the entire backside of the signs so that snow accumulation in the winter does not cause the copper in the treated posts to leach out and come in direct contact with the back of the aluminum signs.

2. It is recommended that the specification for the mounting hardware be changed to require hot-dipped galvanized hardware with a minimum of five (5) mils of protective coating as per WisDOT's Bridge Metals and Fabrication staff.

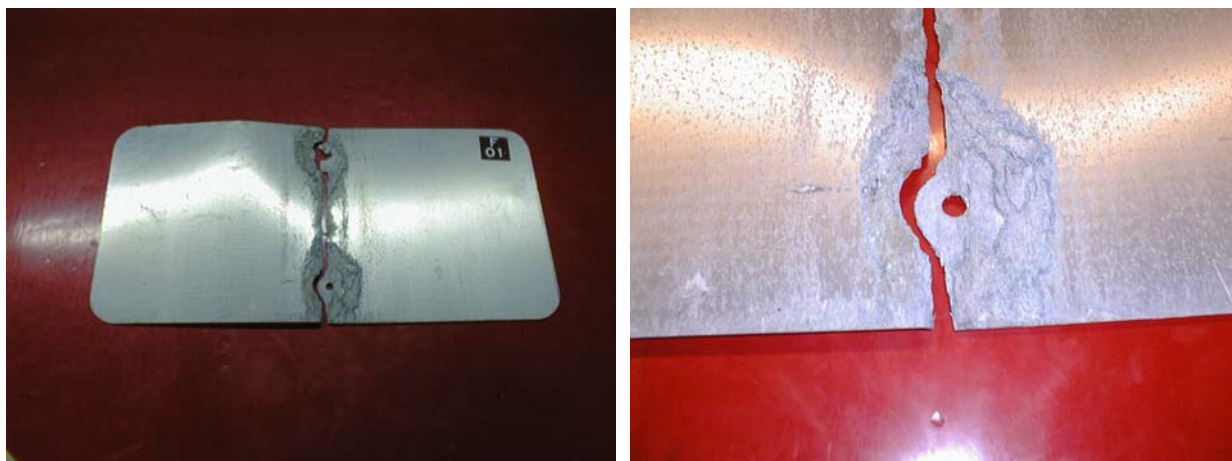
These photographs show another sign mounted on an ACQ post that was in service for approximately 15 months.

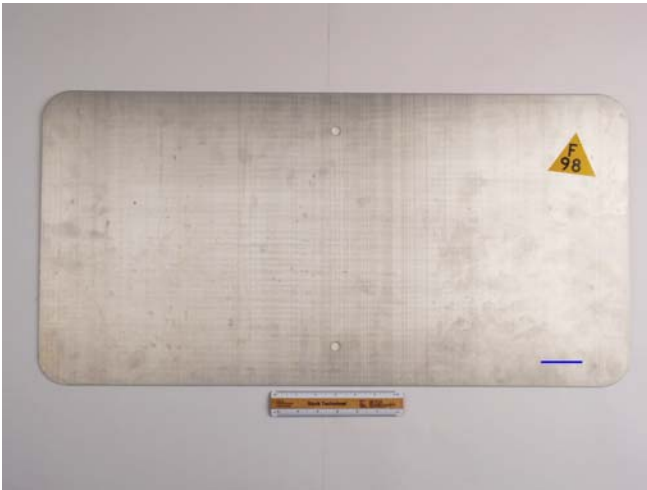
Figure 1
The older Vintage Sign, identified as Sample 1, is shown as-received with the region that was identified for metallographic study indicated by the blue line

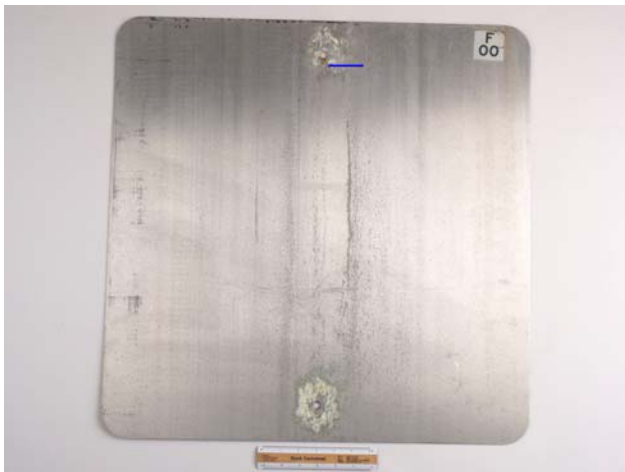
Sample 3 is shown as received in Figure 7, where severe localized corrosion is evident around the lag screw holes. A typical corroded area is shown at higher magnification in Figure 8, where white aluminum corrosion by-products are evident along with a small amount of red rust bleedout adjacent to the edge of the hole. The red rust is likely to arise from corrosion of the adjacent lag screw. A higher magnification view in the vicinity of the corroded area of Sample 3 is shown in Figure 9. In this image relatively non-corroded and corroded regions are both present. Higher magnification views of these two regions are shown in Figures 10 and 11, respectively. The non-corroded regions exhibit parallel grooves and scratches with few surface deposits. The corroded area displays extensive white corrosion deposits. Sample 4 is shown as received in Figure 12. As in Sample 3, localized corrosion is present adjacent to the lag screw holes. A higher magnification view showing a typical corroded area is provided in Figure 13, where aluminum corrosion by-products are present along with the red rust bleedout.

Figure 7
The corroded sign, identified as Sample 3, is shown as-received. Localized corrosion is evident around the lag screw holes. The area that was identified for metallographic study is indicated by the blue line.

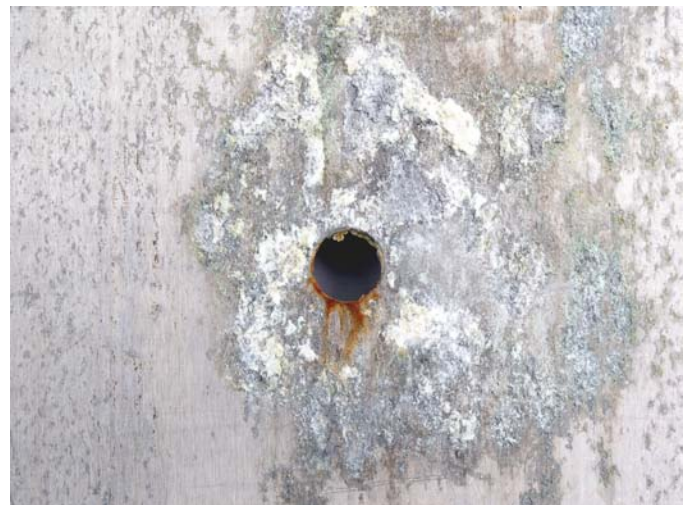
Figure 8
Higher magnification view of a typical corroded area of Sample 3. White corrosion deposits are evident along with some red rust bleedout. (Approx. 1.4X)

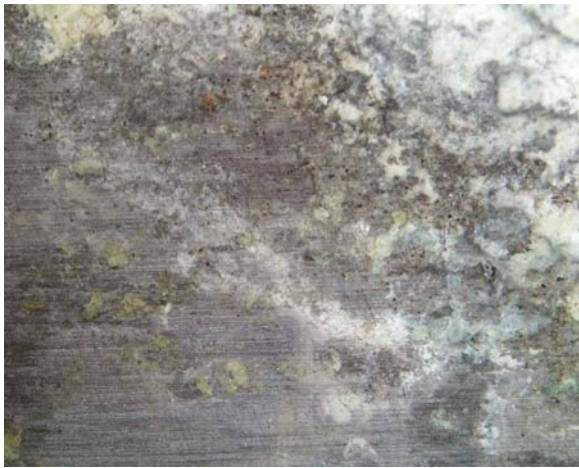
Figure 9
Higher magnification view within the corroded region of Sample 3, showing relatively clean and corroded areas on the surface (Approx. 14X)

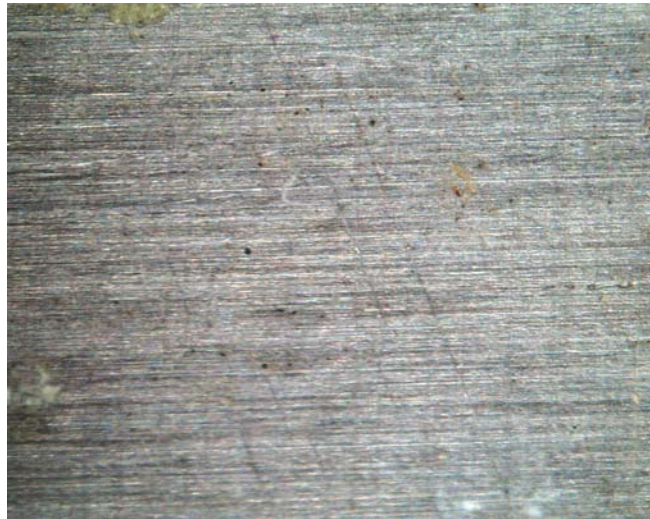
Figure 10
Higher magnification view within a typical relatively clean area of Sample 3, showing parallel grooves and scratches, with some adherent deposits. (Approx. 35X)

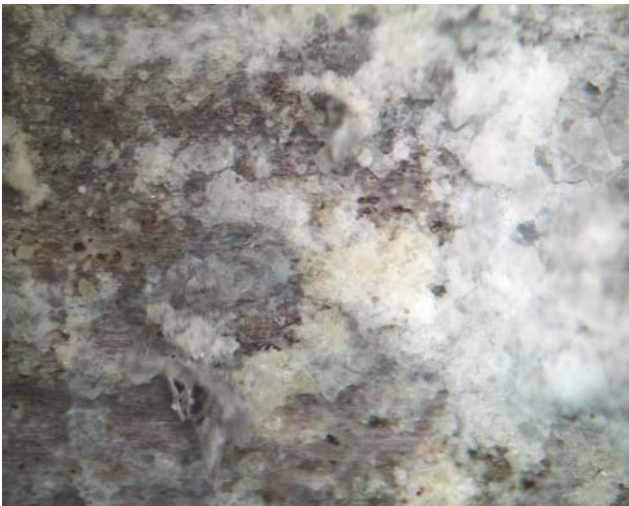
Figure 11
A typical corroded region of Sample 3 exhibits adherent aluminum corrosion products (Approx. 35X).

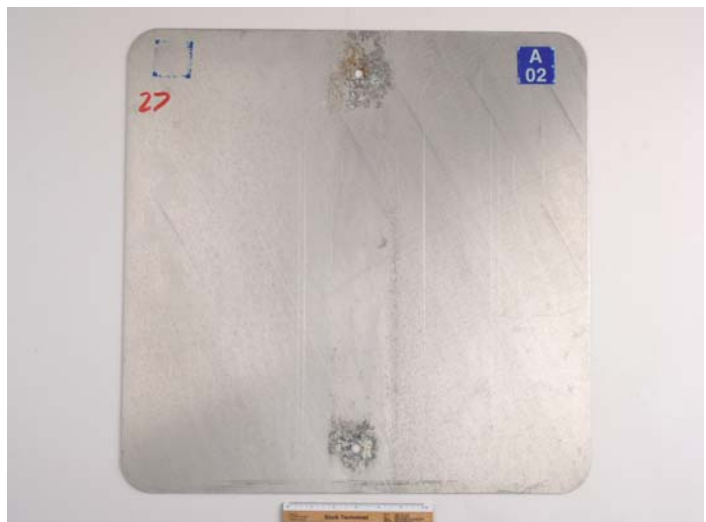
Figure 12
The corroded sign, identified as Sample 4, is shown as-received, where localized corrosion is evident around the lag screw holes.

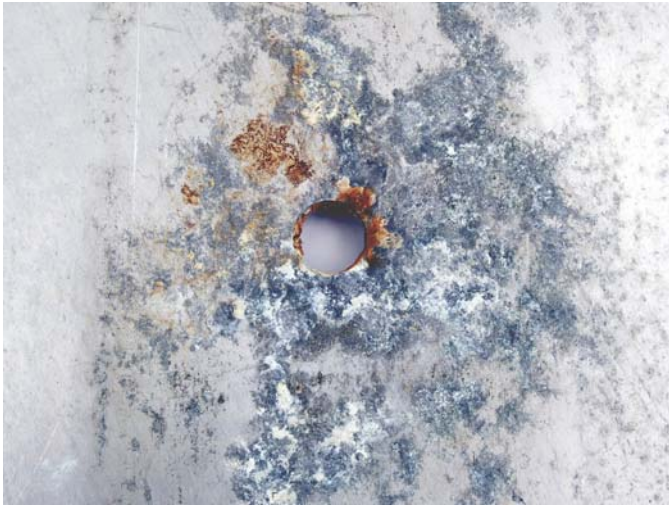
Figure 13
Higher magnification view of a typical corroded area of Sample 4, showing aluminum corrosion products and red rust bleedout (Approx. 1.4X)

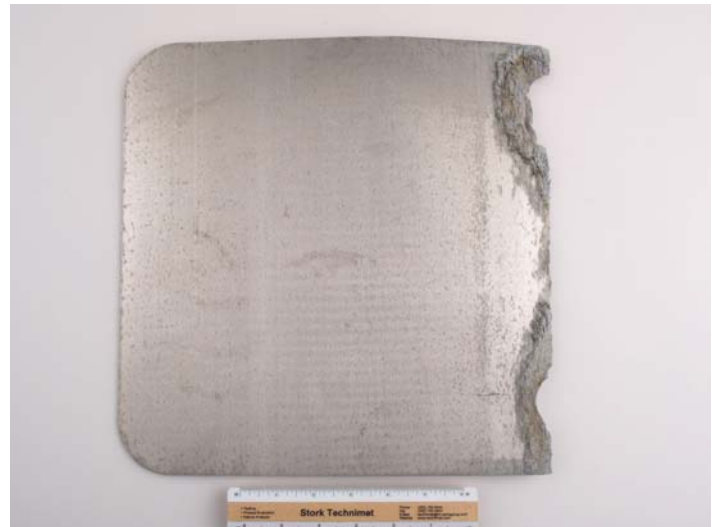
Sample 5 is shown as received in Figure 14. Severe corrosion is evident here that had resulted in the separation of the mating half of the sign. A higher magnification view of the corroded area is provided in Figure 15. This area shows features that are generally consistent with exfoliation corrosion in wrought aluminum. Typical new lag screws are shown as received in Figure 16. All four parts exhibit a shiny silver appearance, which is characteristic of zinc-coated or cadmium-coated components. The lag screw at the left hand side of Figure 16 was designated as Sample 6, and the region of this part identified with the blue line was selected for metallographic study.

Figure 14
The corroded sign section, identified as Sample 5, is shown as-received. Severe corrosion has resulted in separation of the matting half of the sign

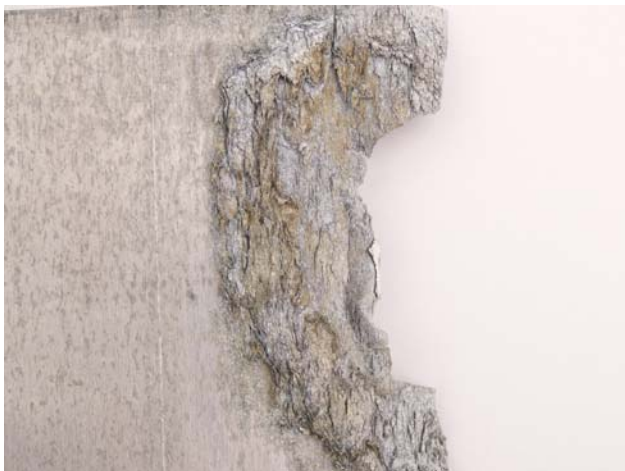
Figure 15
Higher magnification view within a typical corroded area of Sample 5, showing visual features that are generally consistent with exfoliation in wrought aluminum. (Approx. 1X)

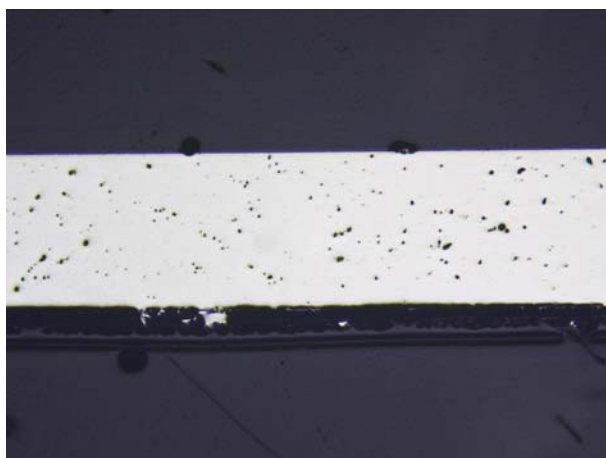
The cross section through Sample 2 is shown in Figure 39 and reveals a much higher level of porosity. Figure 40 shows a 100X magnification of this cross section revealing both the porosity and the iron/chromium rich phases. Figures 41 and 42 provide 500X views of the sample unetched and etched, respectively. These images show the higher degree of porosity and the more scattered arrangement of magnesium silicide particles. The cross section through Sample 3 is shown prior to etching in Figure 43. Severe porosity is evident within the core similar to that observed in Sample 2. In Sample 3 corrosion was also noted along the surface and a typical corroded area is shown in Figure 44. The features in this area are consistent with the severe corrosion of wrought aluminum. The microstructure of this region is shown unetched and etched in Figures 45 and 46, respectively. Here again both magnesium silicide and iron/chromium rich regions are evident. The surface profile of the lag screw Sample 6 is shown in Figure 47. A zinc layer is evident along the surface with an approximate nominal thickness of 0.16 mils.

Figure 39
Transverse metallographic cross section through Sample 2, showing severe porosity. Unetched. (15X)

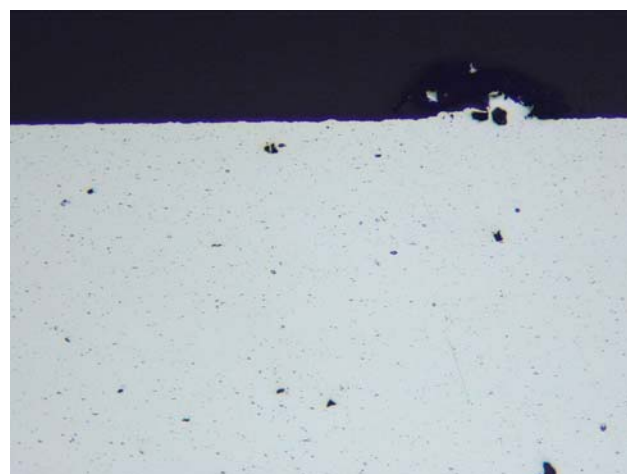
Figure 40
Higher magnification view of the surface profile of Sample 2, showing porosity at the surface and within the core. Iron/chromium-rich phases are also evident. Unetched. (100X)

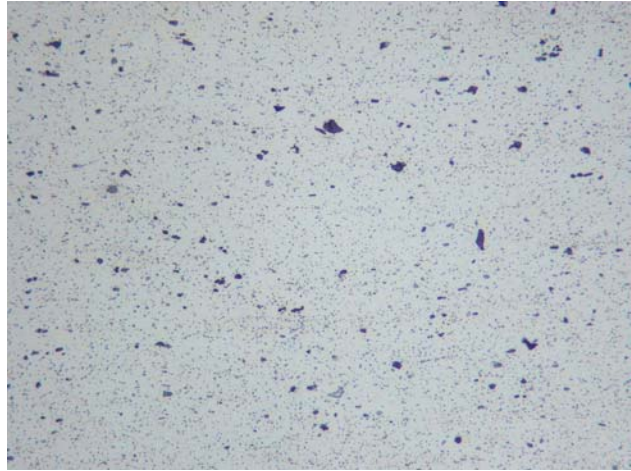
The results of this study show that deterioration had occurred in the newer vintage aluminum signs due to crevice corrosion at the lag screw joints. Some copper was detected within the corrosion products, which may have leached out from the wooden posts treated with the ACQ material. Copper and copper compounds are known to reduce the corrosion resistance of aluminum and aluminum alloys and can actually cause this corrosion. Direct contact between aluminum and copper sets up a galvanic process that can be accelerated by the presence of moisture and other polar by-products and debris such as salts. The elemental composition of the newer vintage sign material shows surface deposits that represent a significant level of oxidation in the aluminum. In addition, the newer vintage aluminum sign contains a much higher level of porosity, which also reduces corrosion resistance. This suggests that the corrosion occurs more rapidly in the newer vintage material due to a combination of porous microstructure and the presence of copper in direct contact with the aluminum.

Figure 43
Transverse metallographic cross section through the corroded area of Sample 3, showing severe porosity in the core, with corrosion along the surface. Unetched. (15X)

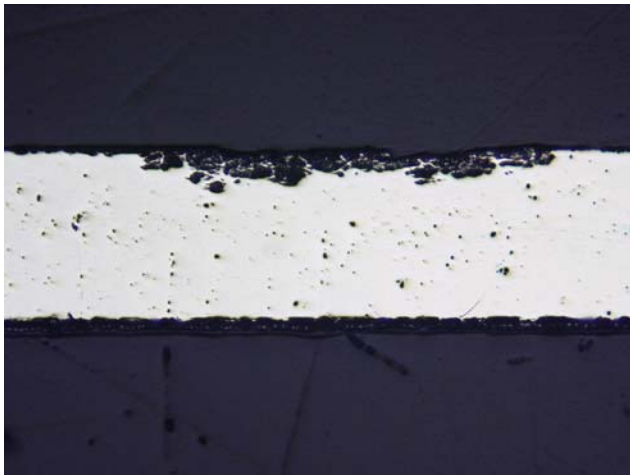
Figure 44
Higher magnification view within the corroded region along the surface of Sample 3. This area exhibits features that are consistent with severe corrosion of wrought aluminum. Unetched. (100X)
